E6086.01-113-11-R0
ACOUSTICAL PERFORMANCE TEST REPORT
ASTM E90

Series/Model: BD-325

Type: Side-Hinged Single Balcony Door System

Report No	E6086.01-113-11
Test Date	04/21/15
Report Date	05/08/15

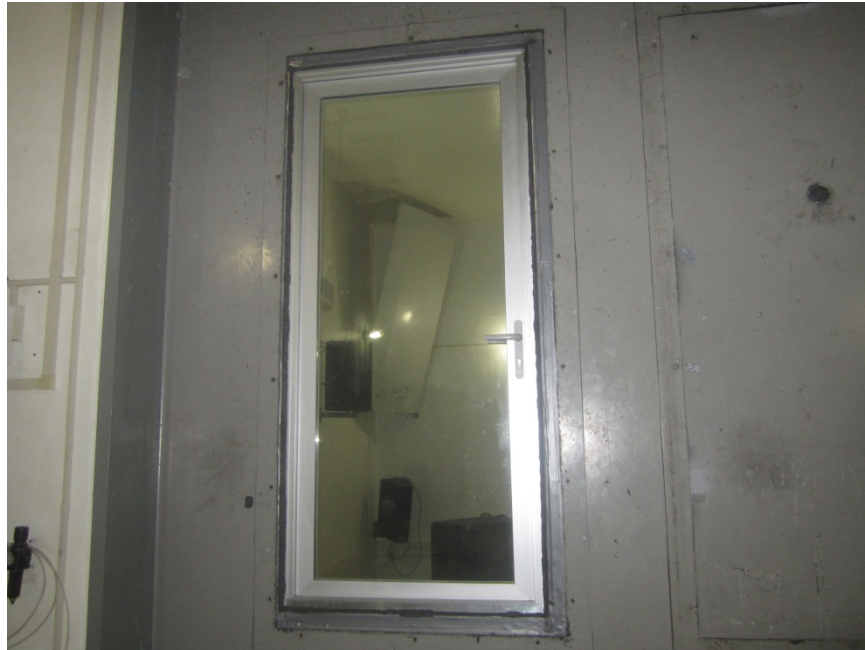
Receive Room View of Installed Specimen

The specimen plug was removed from the filler wall assembly. The specimen was placed on a foam isolation pad in the test opening. Duct seal was used to seal the perimeter of the specimen to the test opening on both sides. The interior side of the specimen frame, when installed, was approximately 1/4" from being flush with the receive room side of the filler wall. A stethoscope was used to check for any abnormal air leaks around the test specimen prior to testing. Operable portions of the test specimen, if any, were cycled at least five times prior to testing.
