### E6086.01-113-11-R0 ACOUSTICAL PERFORMANCE TEST REPORT ASTM E90

### **GAMCO CORPORATION**

Series/Model: BD-325

Type: Side-Hinged Single Balcony Door System

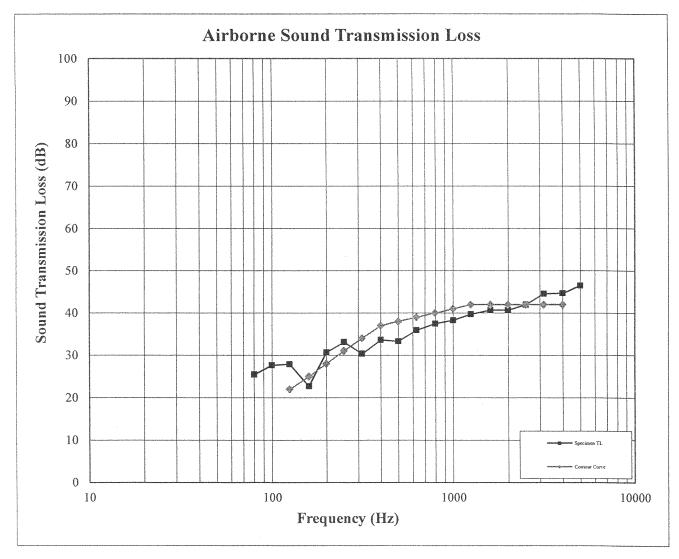
# AIRBORNE SOUND TRANSMISSION LOSS ASTM E 90

Data File No.	E6086.01A1							
Client	Gamco Corpora	tion						
Description  Series/Model: BD-325, side-hinged single balcony door system with 1-1/4" IG ('laminated exterior, 9/16" air space, 1/4" laminated interior), Glass temperature 75°F								
Specimen Area	2.01 m <sup>2</sup>	Receive Temp.	22.4 °C		Source To	emp.	22.5 9	C C
Technician	Daniel P. Platts	Receive Humidity	50%	]	Source H	umidity	48%

Freq	Background SPL	Absorption	Source Receive		Specimen	95%	Number
rreq			SPL	SPL	TL	Confidence	of
(Hz)	(dB)	(m²)	(dB)	(dB)	(dB)	Limit	Deficiencies
80	37.7	4.9	105	77	25.4	2.26	***
100	36.4	4.8	106	76	27.6	1.75	-
125	38.5	4.6	106	75	27.8	1.08	0
160	44.3	4.6	106	80	22.7	1.28	2
200	42.7	4.2	106	72	30.7	0.65	0
250	35.8	4.6	107	70	33.1	0.47	0
315	28.7	5.4	102	67	30.3	0.62	4
400	25.8	5.5	101	63	33.6	0.34	3
500	22.2	5.7	101	63	33.3	0.52	5
630	19.9	5.4	102	61	35.9	0.35	3
800	17.1	5.6	101	59	37.4	0.29	3
1000	12.2	5.8	100	58	38.3	0.34	3
1250	10.3	6.5	98	53	39.7	0.19	2
1600	8.1	6.9	101	55	40.7	0.35	]
2000	6.2	7.3	100	54	40.7	0.31	1
2500	6.3	8.3	98	50	42.0	0.12	0
3150	6.5	10.0	98	47	44.6	0.30	0
4000	7.0	12.2	98	45	44.7	0.30	0
5000	7.6	15.5	95	40	46.5	0.24	-
