**E6085.01-113-11-R0**  
**ACOUSTICAL PERFORMANCE TEST REPORT**  
**ASTM E90**

**GAMCO CORPORATION**

**Series/Model: CW250**

**Type: Two-Lite Curtain Wall System**

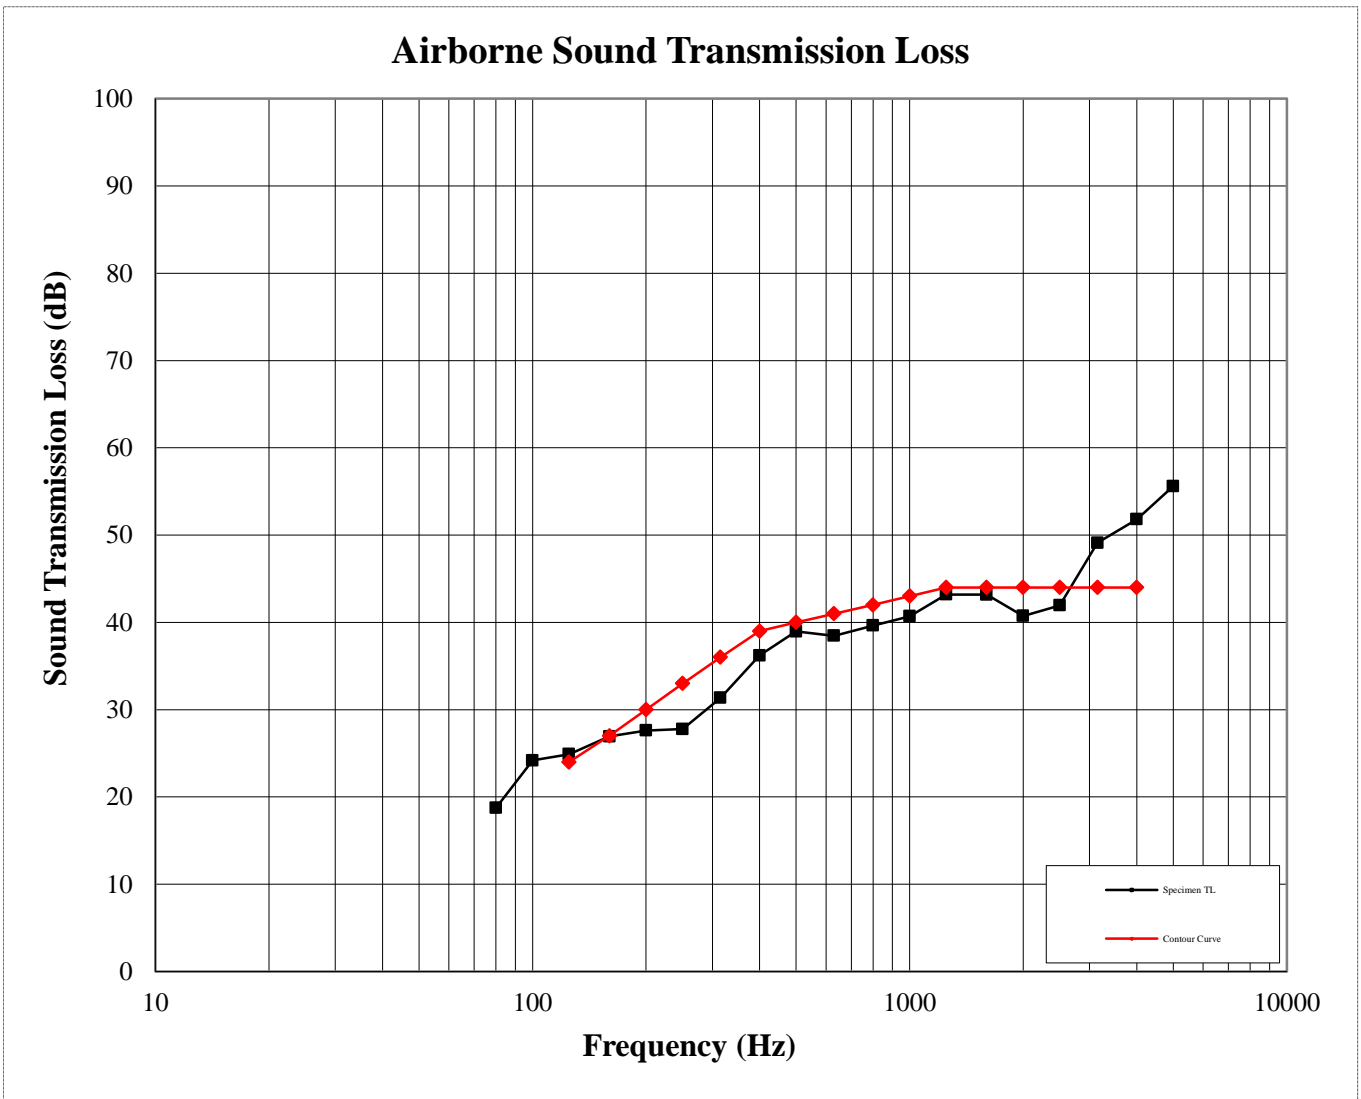
**AIRBORNE SOUND TRANSMISSION LOSS**  
ASTM E 90

<b>Test Date</b>	04/24/15					
<b>Data File No.</b>	E6085.01					
<b>Client</b>	Gamco Corporation					
<b>Description</b>	Series/Model: CW250, two-lite curtain wall system with 1" IG (1/4" tempered exterior, 1/2" argon, 1/4" laminated interior), 1/4" tempered interior secondary glass panel, Glass temperature 75°F					
<b>Specimen Area</b>	4.00 m <sup>2</sup>	Receive Temp.	22.1 °C		Source Temp.	22.1 °C
<b>Technician</b>	Daniel P. Platts	Receive Humidity	51%		Source Humidity	50%

**STC Rating**      **40**      *(Sound Transmission Class)*  
**Deficiencies**      30      *(Sum of Deficiencies)*  
**OITC Rating**      **32**      *(Outdoor-Indoor Transmission Class)*

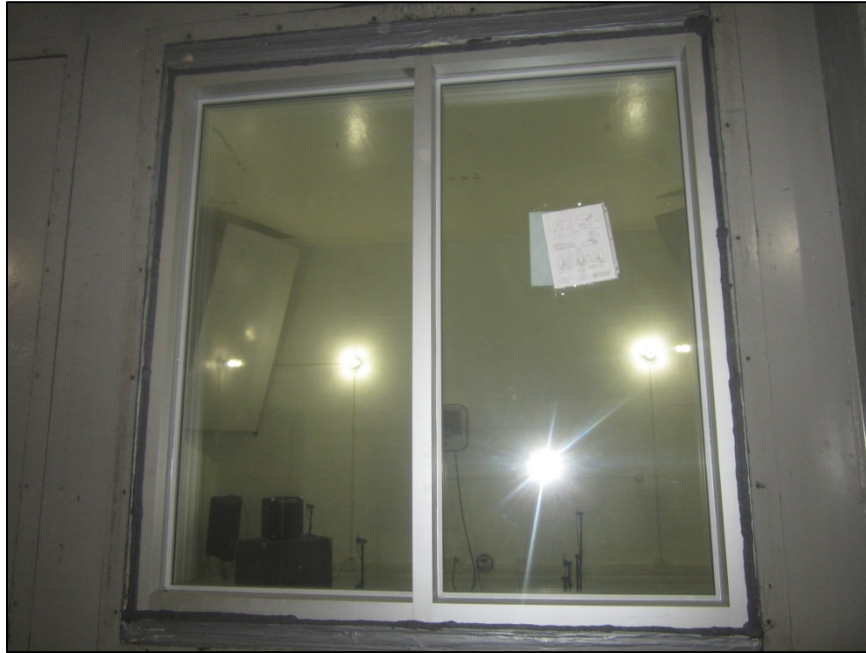
**Receive Room View of Installed Specimen**

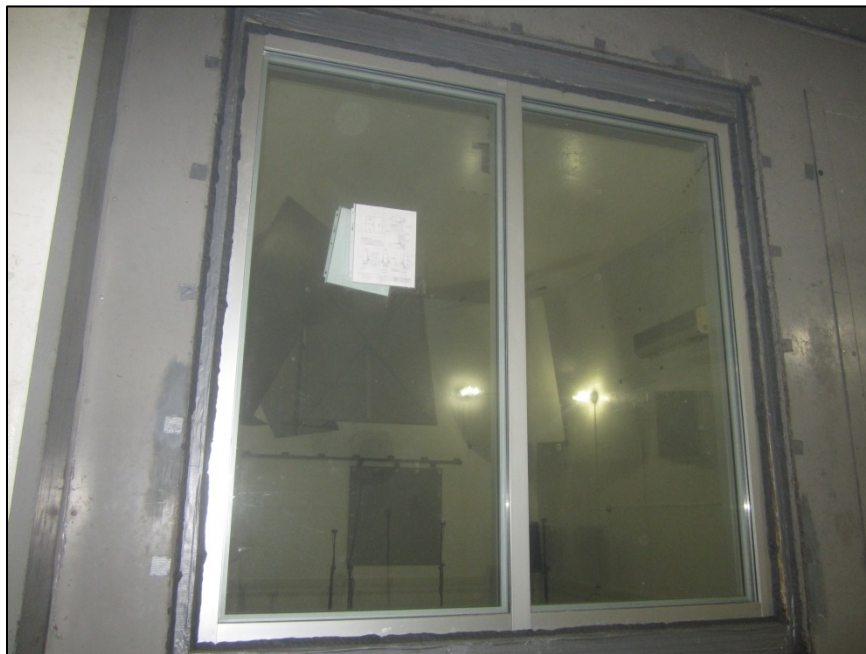
**Source Room View of Installed Specimen**
