GAMCO CORPORATION ACOUSTICAL PERFORMANCE TEST REPORT

ASTM E90 SOUND TRANSMISSION LOSS TESTING ON A
CW250P SERIES, TWO-LITE CURTAIN WALL

M2275.01-113-11-R0

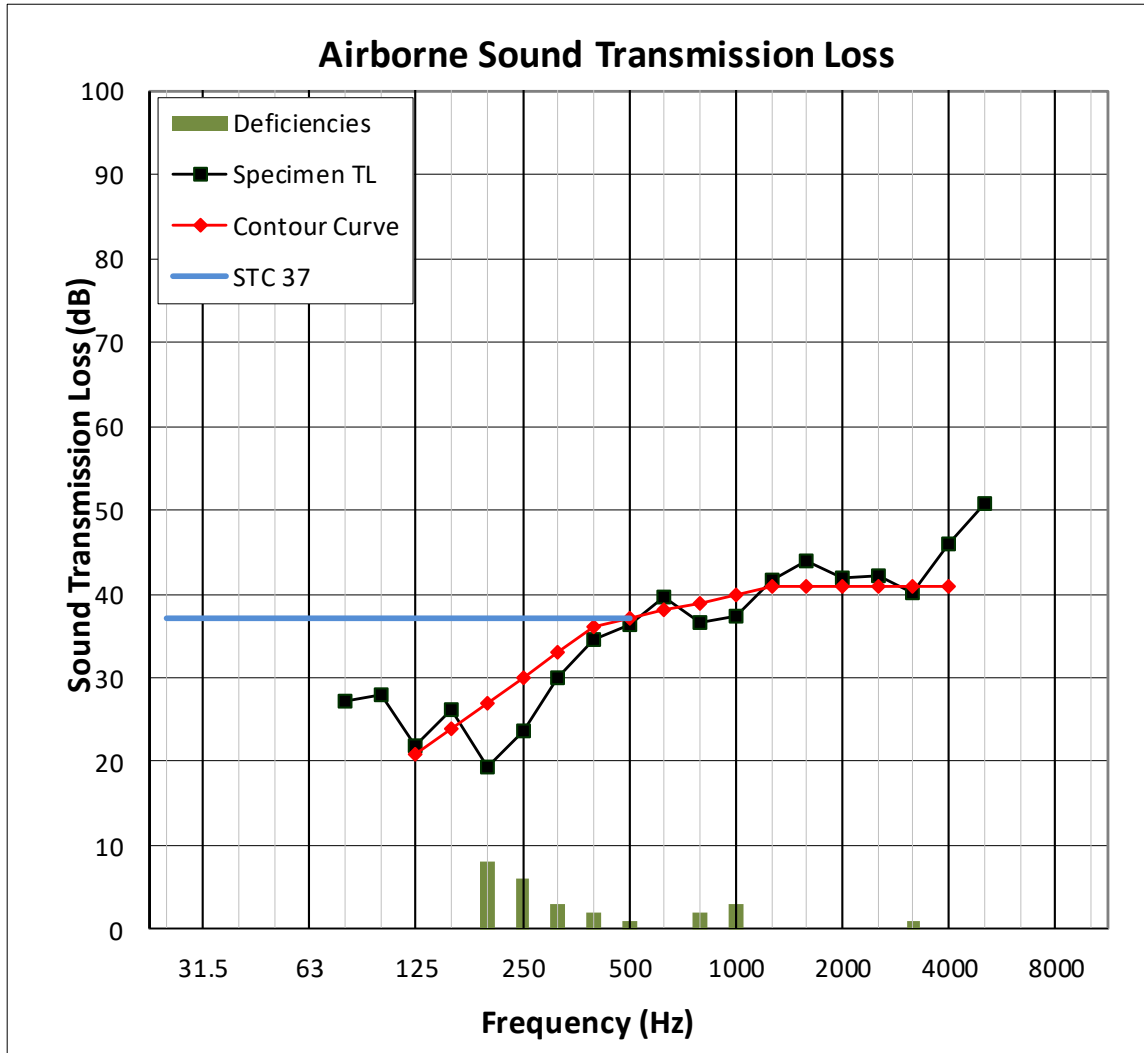
M2275.01 GRAPH

FREQ (Hz)	BACKGROUND SPL (dB)	ABSORPTION (m ²)	SOURCE SPL (dB)	RECEIVE SPL (dB)	SPECIMEN TL (dB)	95% CONFIDENCE LIMIT	NUMBER OF DEFICIENCIES
80	41.6	6.0	108	80	27	1.23	-
100	37.5	5.4	109	81	28	1.89	-
125	37.1	6.6	108	84	22	1.39	0
160	40.1	5.7	110	83	26	0.85	0
200	37.8	5.5	110	89	19	1.28	8
250	31.8	5.7	106	81	24	0.86	6
315	25.4	6.1	109	77	30	0.58	3
400	22.8	6.0	110	74	34	0.40	2
500	18.3	6.3	108	70	36	0.29	1
630	20.3	6.0	107	65	40	0.33	0
800	16.6	6.4	107	68	37	0.36	2
1000	12.2	6.6	107	68	37	0.32	3
1250	8.8	6.9	106	62	42	0.34	0
1600	7.7	7.2	105	58	44	0.31	0
2000	7.1	7.8	105	60	42	0.26	0
2500	7.1	8.9	106	61	42	0.28	0
3150	7.4	10.5	104	60	40	0.22	1
4000	8.2	13.2	102	51	46	0.21	0
5000	8.9	16.8	103	46	51	0.35	-
STC RATING	37 (Sound Transmission Class)						
DEFICIENCIES	26 (Sum of Deficiencies)						
OITC RATING	30 (Outdoor-Indoor Transmission Class)

Transmission loss (TL) at each 1/3 octave frequency is the average source room sound pressure level minus the average receive room sound pressure level, plus, 10 times the log of the specimen area divided by the sound absorption of the receive room with the sample in place.

To obtain the Sound Transmission Class (STC), read the TL of the contour curve at 500 Hz. The sum of the deficiencies below the contour curve must not exceed 32. The maximum deficiency at any one frequency must not exceed 8.

The Outdoor-Indoor Transmission Class (OITC) is calculated by subtracting the logarithmic summation of the TL values from the logarithmic summation of the A-weighted transportation noise spectrum stated in ASTM E1332.

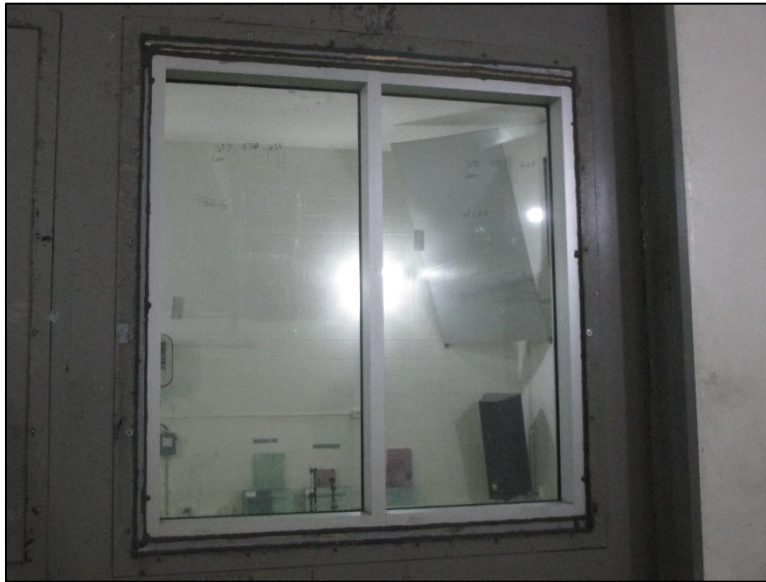
Photo No. 1
Receive Room View of Installed Test Specimen

FRAME
SIZE	78-3/4" by 81-1/4"
THICKNESS	7-7/8"
CORNERS	Butted
FASTENERS	Screws
SEAL METHOD	Sealant
MATERIAL	Aluminum
REINFORCEMENT	N/A
THERMAL BREAK MATERIAL	Polyamide pressure bar with rubber gasket
DAYLIGHT OPENING SIZE (X2)	35-5/8" by 76-1/4"

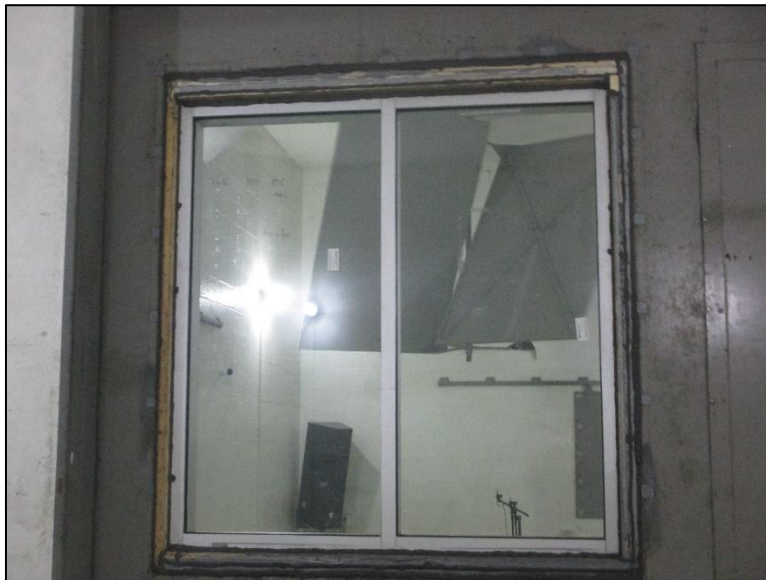
Photo No. 2
Source Room View of Installed Test Specimen
