ACOUSTICAL PERFORMANCE TEST REPORT

ASTM E90 SOUND TRANSMISSION LOSS TESTING ON A
D350, SIDE-HINGED SINGLE DOOR SYSTEM

K4566.02-113-11-R0

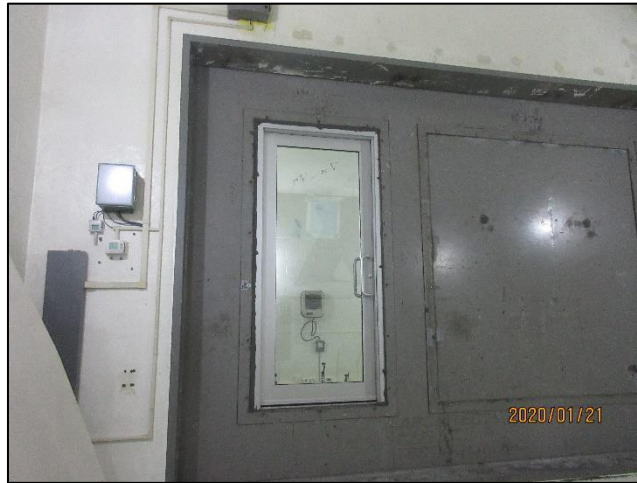
Photo No. 1
Receive Room View of Installed Test Specimen

The specimen plug was removed from the filler wall assembly. The specimen was placed on an isolation pad in the test opening. Duct seal was used to seal the perimeter of the specimen to the test opening on both sides. The interior side of the specimen, when installed, was approximately 1/4" from being flush with the receive room side of the filler wall. A stethoscope was used to check for any abnormal air leaks around the test specimen prior to testing. Operable portions of the test specimen, if any, were cycled at least five times prior to testing.

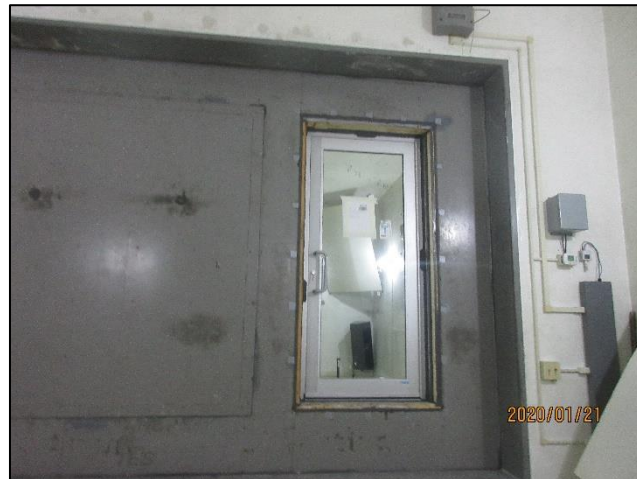
Photo No. 2
Source Room View of Installed Test Specimen
