TEST REPORT

REPORT No.: 2140.03-106-11

PRODUCT TYPE: Aluminum Fixed Storefront System

SERIES / MODEL: FG451T

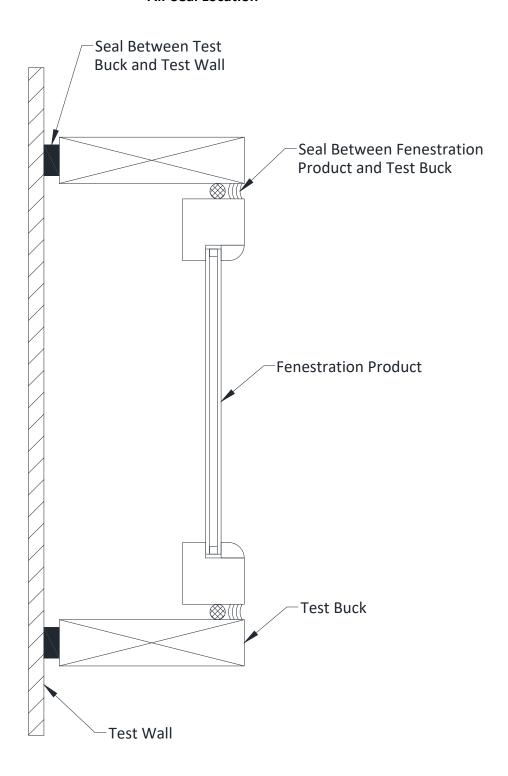
Appendix B

Air Seal Location

Note 9: Tape and film were not used to seal against air leakage.

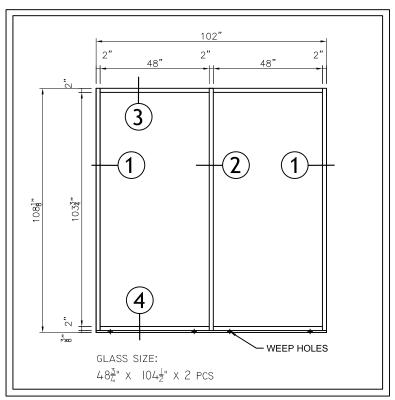
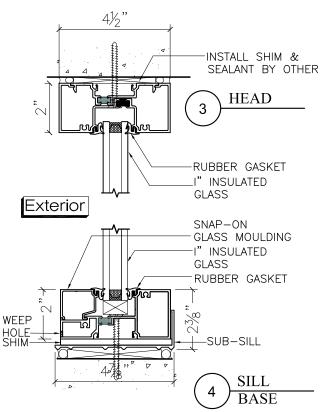
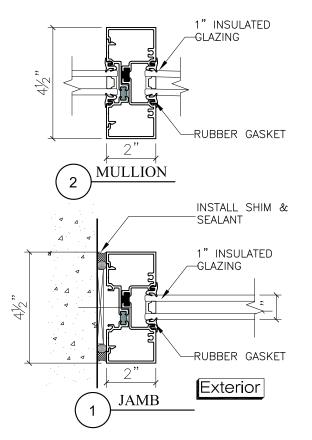
Drawings

FG45IT STOREFRONT

I" I.G. ($\frac{1}{4}$ " CLR. TM. $\frac{1}{2}$ " AIR $\frac{1}{4}$ " CLR. TM.)

Drawing Reference: The test specimen drawings were supplied by the client. The test specimen construction was verified by Molimo and was found to be representative of the product tested. Test specimen drawings are located in Appendix C of this report.

Description	Detail
Glass Type	1" IG
	1/4" Thick tempered glass
Glazing Construction	1/2" Aluminum box spacer system
(Exterior to Interior)	1/4" Thick tempered glass
Glazing Method	Channel glazed using interior and exterior glazing gaskets. The sill utilized a snap-in aluminum glazing bead on the exterior.
Glazing Bite	1/2"
Daylight Opening (2)	1207 mm x 2623 mm (47-1/2" x 103-1/4")
