GAMCO CORPORATION ACOUSTICAL PERFORMANCE TEST REPORT

ASTM E90 SOUND TRANSMISSION LOSS TESTING ON A
TD350 + FG451IS, SINGLE STOREFRONT DOOR

P9396.01-113-11-R0

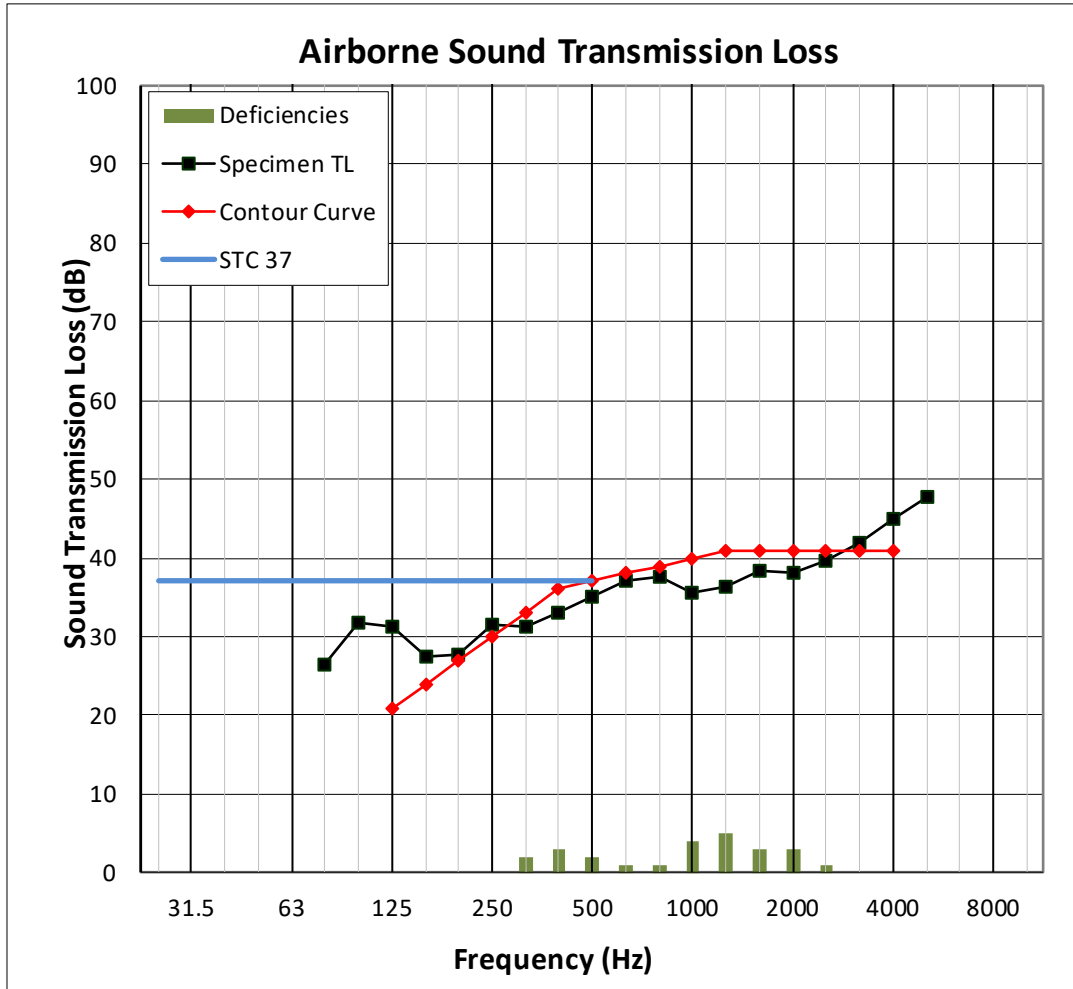
P9396.01B2 GRAPH

FREQ (Hz)	BACKGROUND SPL (dB)	ABSORPTION (m ²)	SOURCE SPL (dB)	RECEIVE SPL (dB)	SPECIMEN TL (dB)	95% SAMPLING LIMIT	NUMBER OF DEFICIENCIES
80	30.9	5.9	105	75	26	2.02	-
100	26.4	6.2	107	71	32	1.59	-
125	31.1	6.0	107	72	31	0.90	0
160	37.5	6.1	109	77	27	1.01	0
200	35.8	6.4	108	75	28	0.84	0
250	31.4	6.7	104	67	32	0.73	0
315	28.9	6.3	105	69	31	0.48	2
400	27.8	6.2	103	66	33	0.63	3
500	26.3	6.0	104	64	35	0.36	2
630	24.7	6.3	104	62	37	0.38	1
800	25.3	6.6	102	59	38	0.29	1
1000	24.2	6.7	104	63	36	0.20	4
1250	25.0	7.0	102	60	36	0.27	5
1600	19.9	7.4	100	56	38	0.22	3
2000	11.9	7.9	102	58	38	0.33	3
2500	8.5	9.1	103	56	40	0.30	1
3150	7.4	10.8	101	52	42	0.30	0
4000	8.1	13.2	99	46	45	0.26	0
5000	9.0	16.7	99	42	48	0.46	-
STC RATING	37 (Sound Transmission Class)						
DEFICIENCIES	25 (Sum of Deficiencies)						
OITC RATING	34 (Outdoor-Indoor Transmission Class)

Transmission loss (TL) at each 1/3 octave frequency is the average source room sound pressure level minus the average receive room sound pressure level, plus, 10 times the log of the specimen area divided by the sound absorption of the receive room with the sample in place.

To obtain the Sound Transmission Class (STC), read the TL of the contour curve at 500 Hz. The sum of the deficiencies below the contour curve must not exceed 32. The maximum deficiency at any one frequency must not exceed 8.

The Outdoor-Indoor Transmission Class (OITC) is calculated by subtracting the logarithmic summation of the TL values from the logarithmic summation of the A-weighted transportation noise spectrum stated in ASTM E1332.

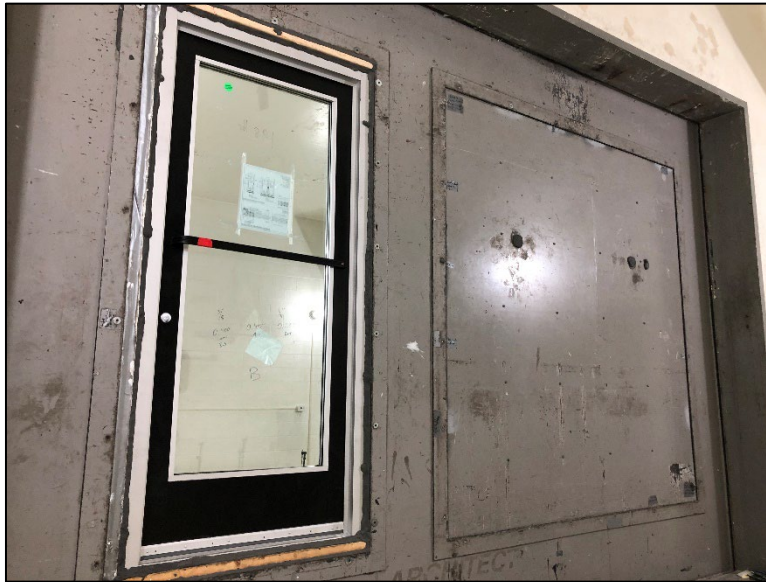
Photo No. 1
Receive Room View of Installed Test Specimen

The specimen plug was removed from the filler wall assembly. The specimen was placed on an isolation pad in the test opening. Duct seal was used to seal the perimeter of the specimen to the test opening on both sides. The interior side of the specimen, when installed, was approximately 1/4" from being flush with the receive room side of the filler wall. A stethoscope was used to check for any abnormal air leaks around the test specimen prior to testing. Operable portions of the test specimen, if any, were cycled at least five times prior to testing.

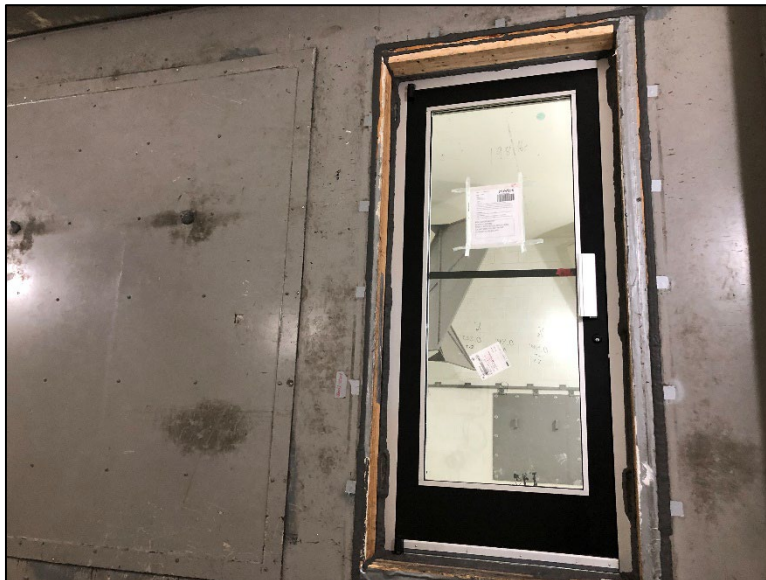
Photo No. 2
Source Room View of Installed Test Specimen

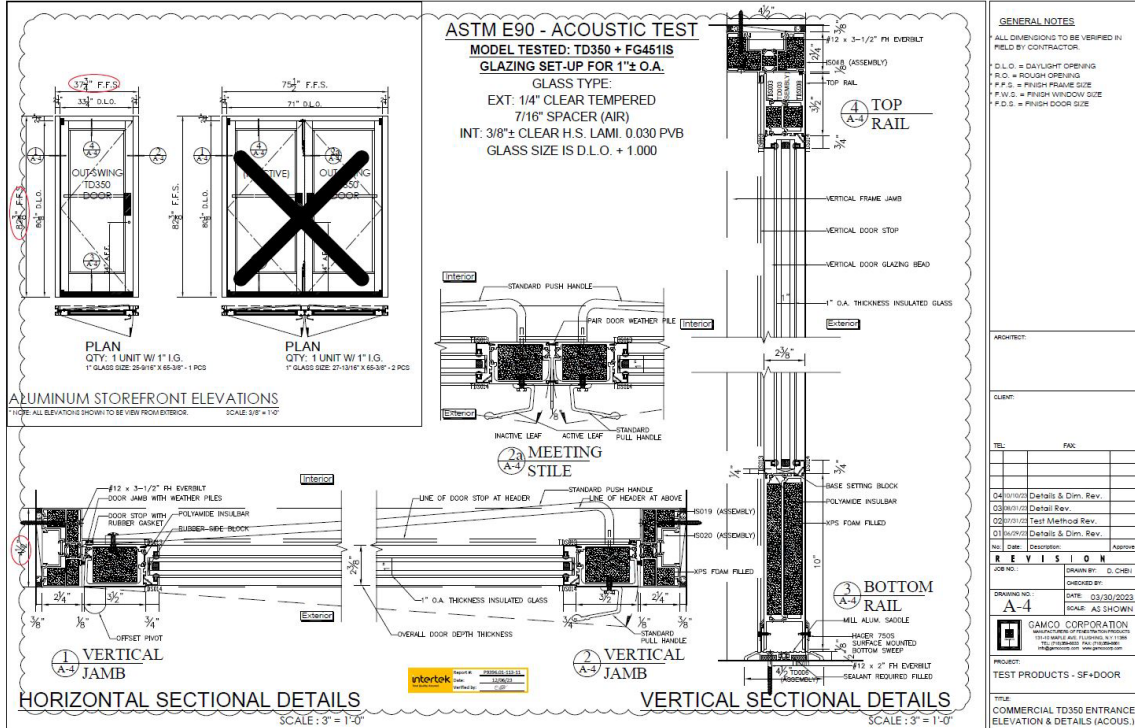
SECTION 12 DRAWINGS

Drawings of the test specimen are included in Section 12.

FRAME	LEAF
SIZE	37-3/4" by 82-3/8"	32-7/8" by 79-3/8"
THICKNESS	4-1/2"	2-3/8"
CORNERS	Butted	Butted
FASTENERS	Screws	Screws
SEAL METHOD	Sealant	Sealant
MATERIAL	Aluminum	Aluminum
REINFORCEMENT	N/A	N/A
THERMAL FILL	XPS Foam	XPS Foam
THERMAL BREAK MATERIAL	Insulbar	Insulbar
DAYLIGHT OPENING SIZE	N/A	24-1/2" by 64-1/4"
