# **TEST REPORT**

REPORT No.: 1931.04-106-11

PRODUCT TYPE: Aluminum Outswing Twin Casement Window

SERIES / MODEL: W250HC

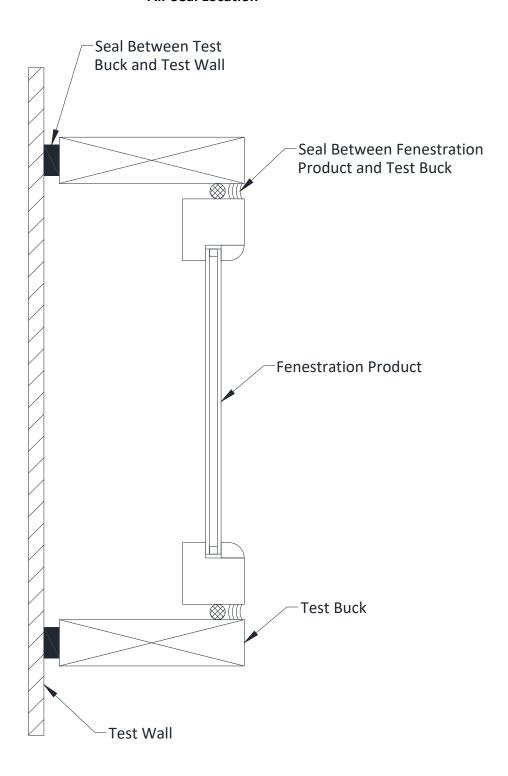
#### **Air Seal Location**

Note #6: Tape and film were used to seal against air leakage. In our opinion, the tape and film did not influence the results of the test.

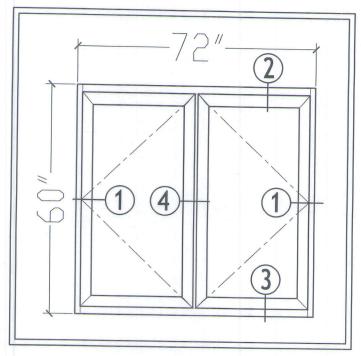
# W250HC SERIES WINDOW SWING-OUT TWIN CASEMENT

BOM: W250HC-SWING-OU	T TWIN-CASEMENT	
ITEM	DESCRIPTION	PART NO.	QTY.
1	250C/HC Window Head/Sill	H-16980	2
2	250HC Main Frame	H-2656	2
3	250HC Project-out	H-2660	8
4	250 Corner Key	S-13020	16
5	250 1" Glazing Bead	S-13014	8
6	Casement Hinge, Stainless Steel	WH1H4395	6
7	Casement Cam Lock	WH2L241G	2
8	Casement Lock Handle	WH2L242G	2
9	Lock Keeper	WH7K2108	4
10	Casement Stainless track	WH7T1325	2
11	Crank/Knob Handle	WH7H105G	2
12	Rotary Operatoer 13.5" right hand	WH3R348G	2
13	Setting Block	WH6N582	4
14	Butyl Tape for 1" I.G.	WH5G3654	8
15	Rubber Apply for 1" I.G.	WH6U3175	8
16	T-slot Bulb Seal Rubber	WH5T175B	16
17	Insulated Glass 1"	1/8" x 1/8"	-
18	Locking Block	WH7B2011	2
19	Anti-Drop	WH7B1630	2
20	250 Muntin	H-2652	1
