TEST REPORT

REPORT NO.: 2140.02-106-11

PRODUCT TYPE: Aluminum Fixed Storefront System

SERIES / MODEL: FG451

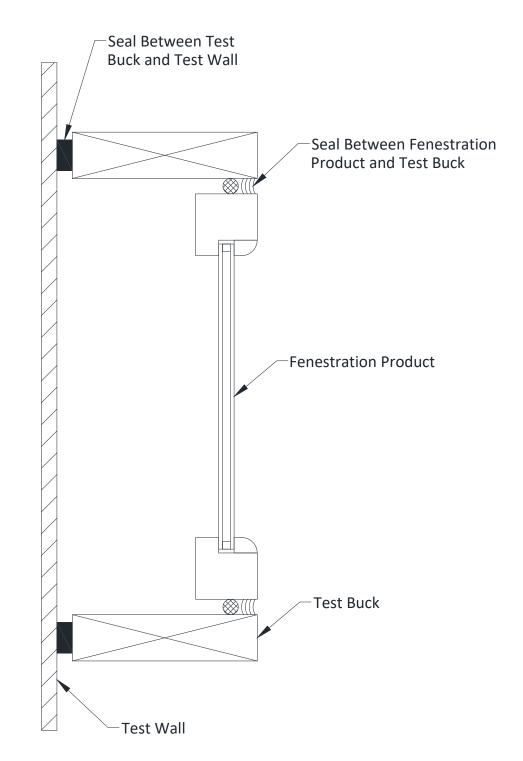
Air Seal Location

Note 5: Tape and film were not used to seal against air leakage.

Note 9: Tape and film were not used to seal against air leakage.

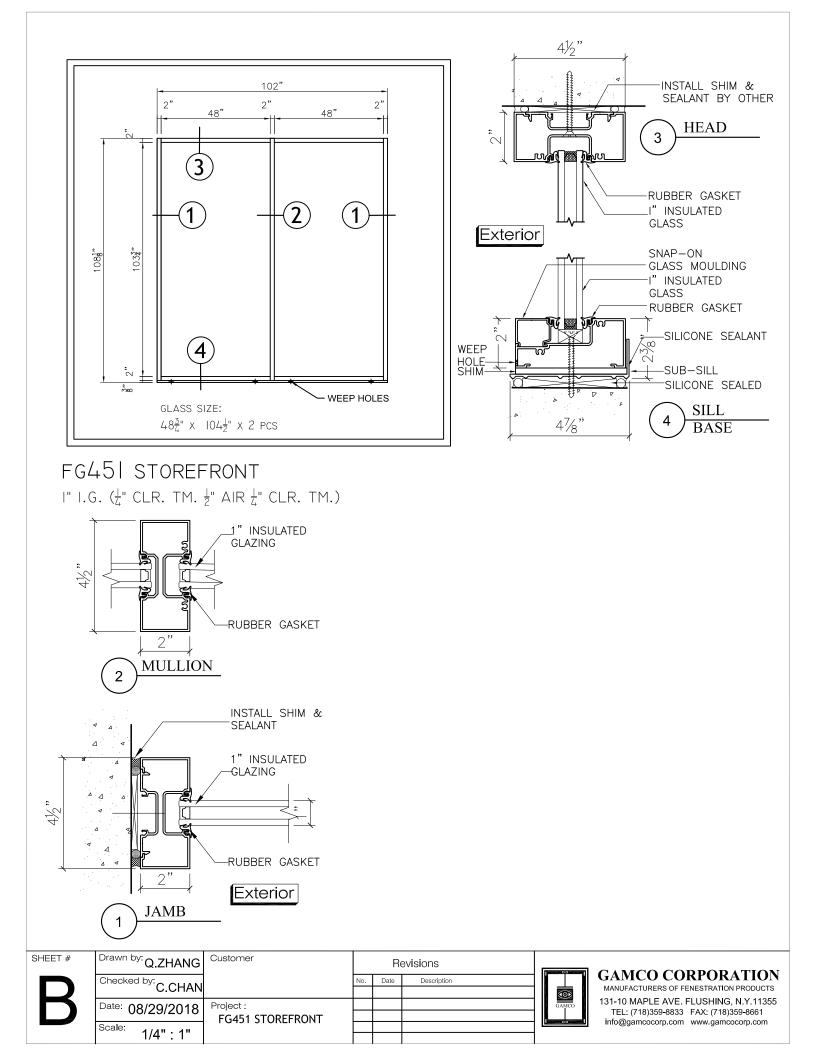
Drawings

Drawing Reference: The test specimen drawings were supplied by the client. The test specimen construction was verified by Molimo and was found to be representative of the product tested. Test specimen drawings are located in Appendix C of this report.

Material:	Extruded aluminum	
Connection Details:	Square-cut and butted, sealed with silicone, and secured with two #10 x 1" pan head screws per horizontal/vertical intersection	
Other Details:	All vertical members incorporated a 2-piece extruded aluminur member. The snap-on frame piece was secured to the mai vertical member using #8 x 1/2" flat head screws, spaced maximum of 16" on center.	
	The sill utilized an extruded sill pan with a 0.035" thick aluminum end dam. The end dam was secured to the sill pan with silicone.
